Don Morley has removed the primary transmission of his Royal Enfield's transmission and is now ready to take off the final drive sprocket and get to the Albion gearbox itself.

# TACKLING THE GEARBOX — THE EASY BIT!

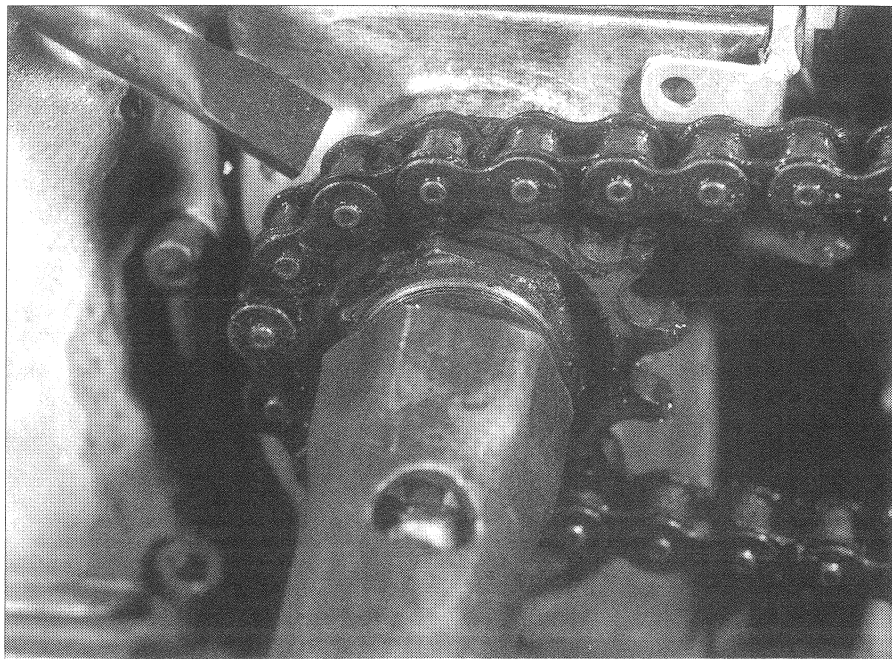
- Unless everything has been properly cleaned it is all too easy to miss the presence (hopefully!) of a taper threaded and headless lock screw fitted into one of the two holes within the hardened sprocket's centre (**diagram two**). More specifically, the screw should be fitted to the hole is closest to the sleeve nut to stop the latter undoing itself when the machine is in motion.

- This vital screw is re-usable but is

made of mild steel and can be easily damaged. It is very important, therefore to use a screwdriver that is a good fit into the screw's slot, so good in fact that there is no risk at all of it slipping and damaging the head. Do that and the screw will need to be chiselled off and the remainder drilled out.

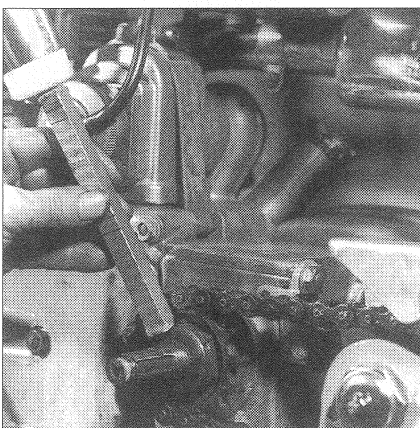
It is exceedingly difficult to get at this with anything other than a long, large, fairly thin-walled box spanner, (**pic one**) the type of tool very few of us are likely to have to hand. More of this potential problem later.

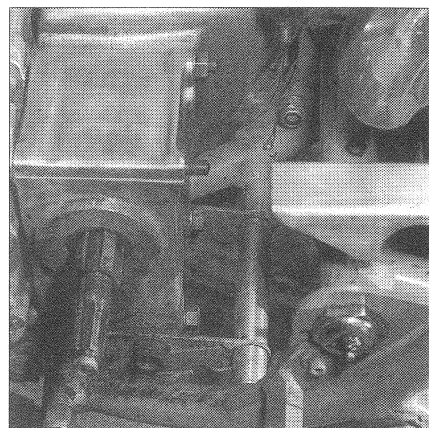
- The sleeve nut itself is, in my experience, unlikely to be particularly tight or difficult to get off once the lock screw is out. That's fortunate for me because I've never possessed the ideal size box spanner I described earlier. Luckily a few sharp hammer taps with an alloy drift (**pic three**) on the butt's extreme hexagon edges (obviously in an anti-clockwise direction) has never yet failed to work!

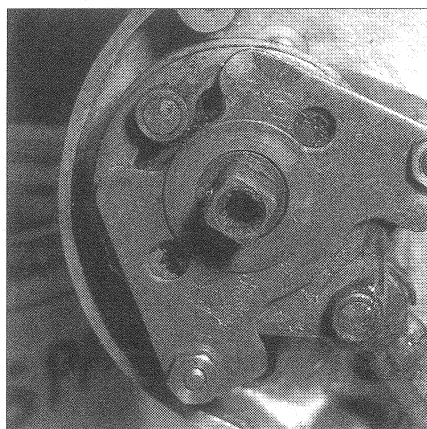
box shaft from turning. That's precisely why we deliberately left the rear chain fitted. Now this job is done it too can be removed complete with the final drive sprocket (pic four).

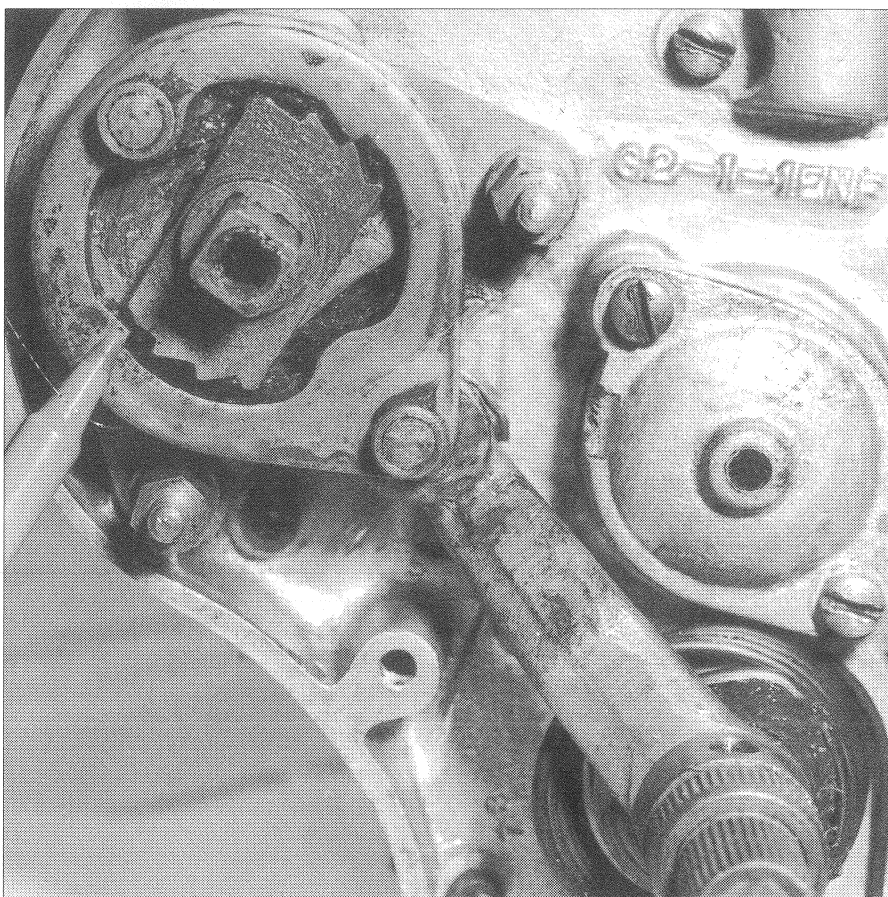
● **Picture five** shows the cleaned-up gear selector mechanism and the two very thin nuts which need removing from their pillar bolts. As will soon be seen, these bolts should always be stopped from accidentally turning by using a separate locking spanner when the thin nuts are removed — or fitted.

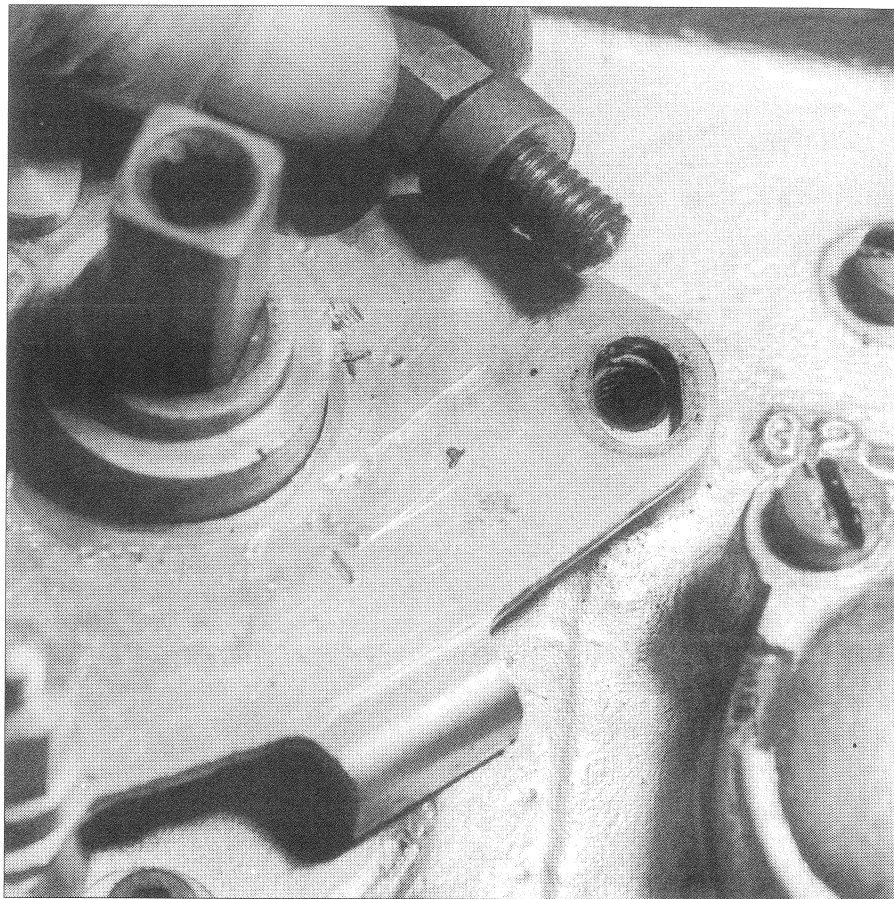
● The selector striker can be seen in its *correctly* fitted position after the thin nuts and outer cover plate has been removed (**pic six**). Note that there should also be a large diameter shim laying outside of the outer cover plate.

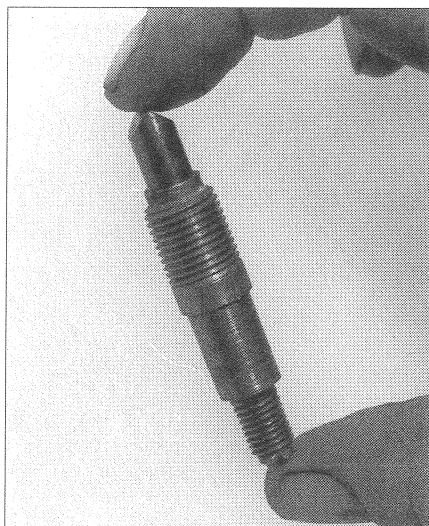
- Now undo the first of those pillar bolts (**pic seven**). This will reveal the back plate, slotted to provide the selector mechanism with a pivotal range of adjustments.

- The precise position of this backplate should be accurately marked by scribing lines or centre-popping indentations on both the backplate and the gearbox housing *before* the second pillar bolt is undone to reveal the two final inner gearbox cover fixing bolts lurking behind it.

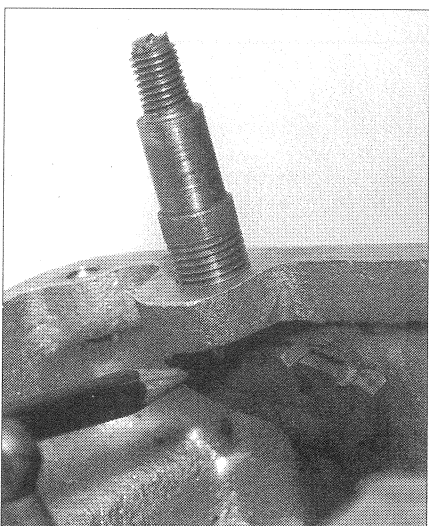
- This little spring loaded detente device (**pic eight**) passes through an unthreaded hole in the gearbox's inner

cover and screws into the box's main casing behind it.

- A most important point when dealing with the detente plunger, is to make sure the slot on the adjustment end must always lie horizontally across the gearbox. If not, the wedge shaped end will not be in the right position to slot into the selector grooves. This is why the plunger should be held in position with a screwdriver in its slot while adjusting the lock nut.

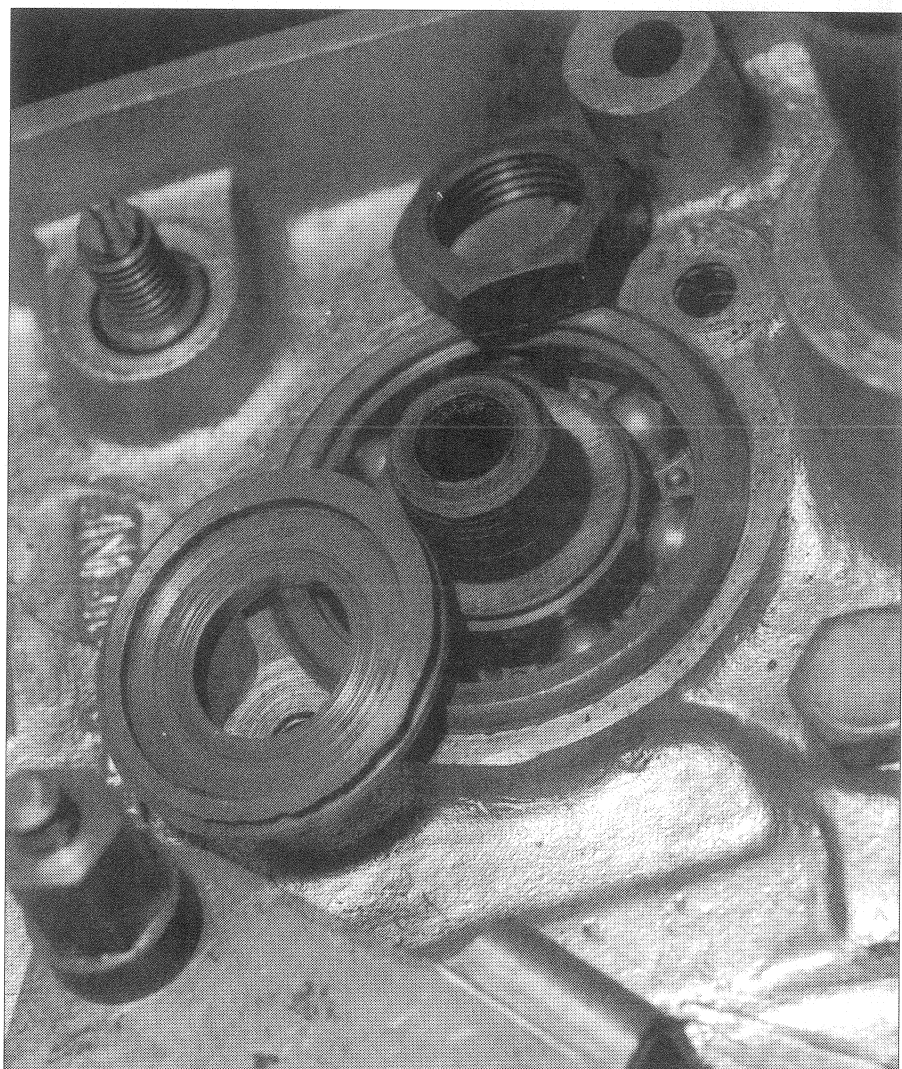
- Its hardened, wedge-shaped end locates in notches on the final gear selector fork (**pic nine**) and the further in the plunger is screwed, the more the pressure on the selector fork. This can be tightened to the point where brute force is required on the gear lever, or loosened to steadily lighten the gearshift feel. Too loose, however, and there's the risk of the bike jumping out of gear.

- Having explained that, pause at this point if you were contemplating stripping the whole gearbox because it has been jumping out of gear — adjustment to this plunger may be all that is necessary!

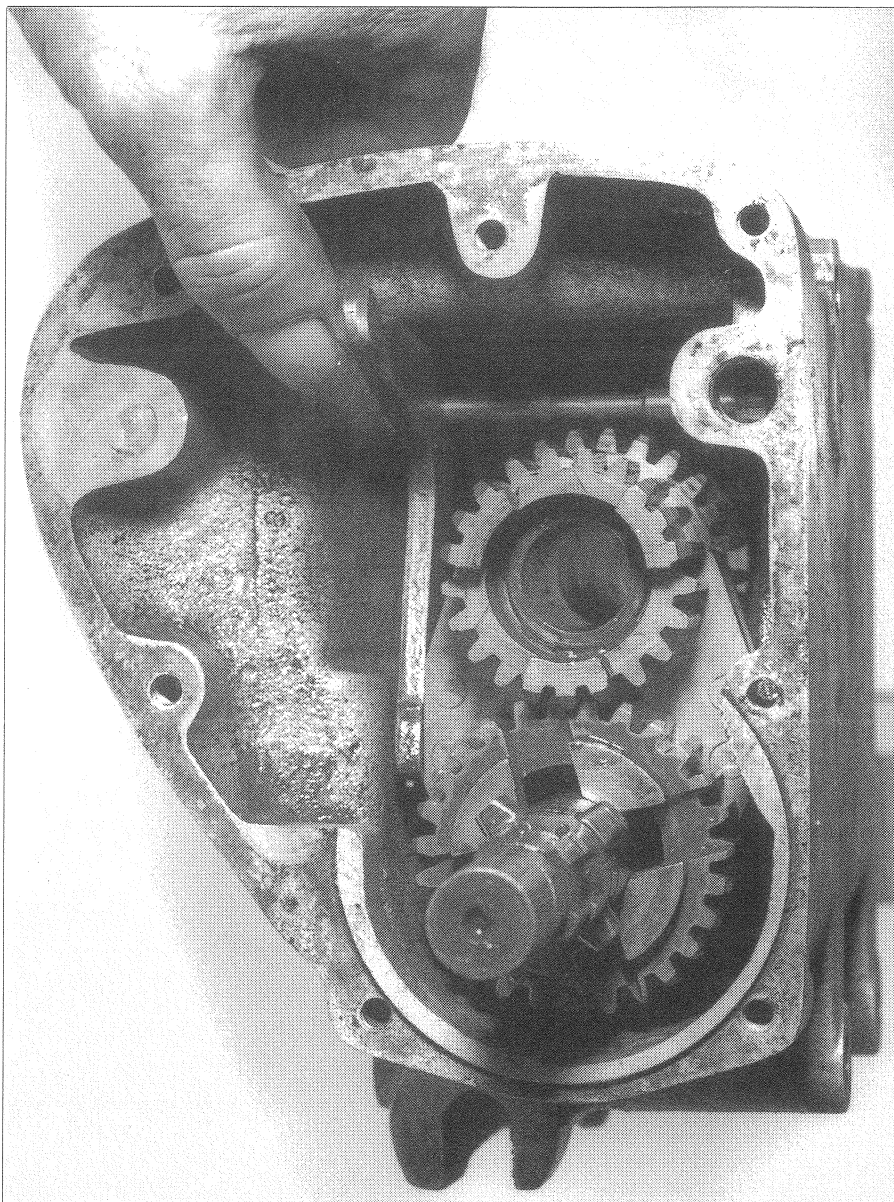
- Now we must remove the gearbox main shaft's retaining nut and oil thrower (**pic ten**). Note this particular nut has a *left hand* thread. Also note that, regardless of how it is actually fitted, the correct position for the oil thrower ring is to have the left hand threaded nut lying inside the thrower's recess; ie with its flange facing outwards.

- Again, this is ignored in Royal Enfield's manual, along with the fact there is an identical thrower ring situated inside the gearbox, up against the same bearing, that should be fitted facing inwards; ie in the exact opposite direction.

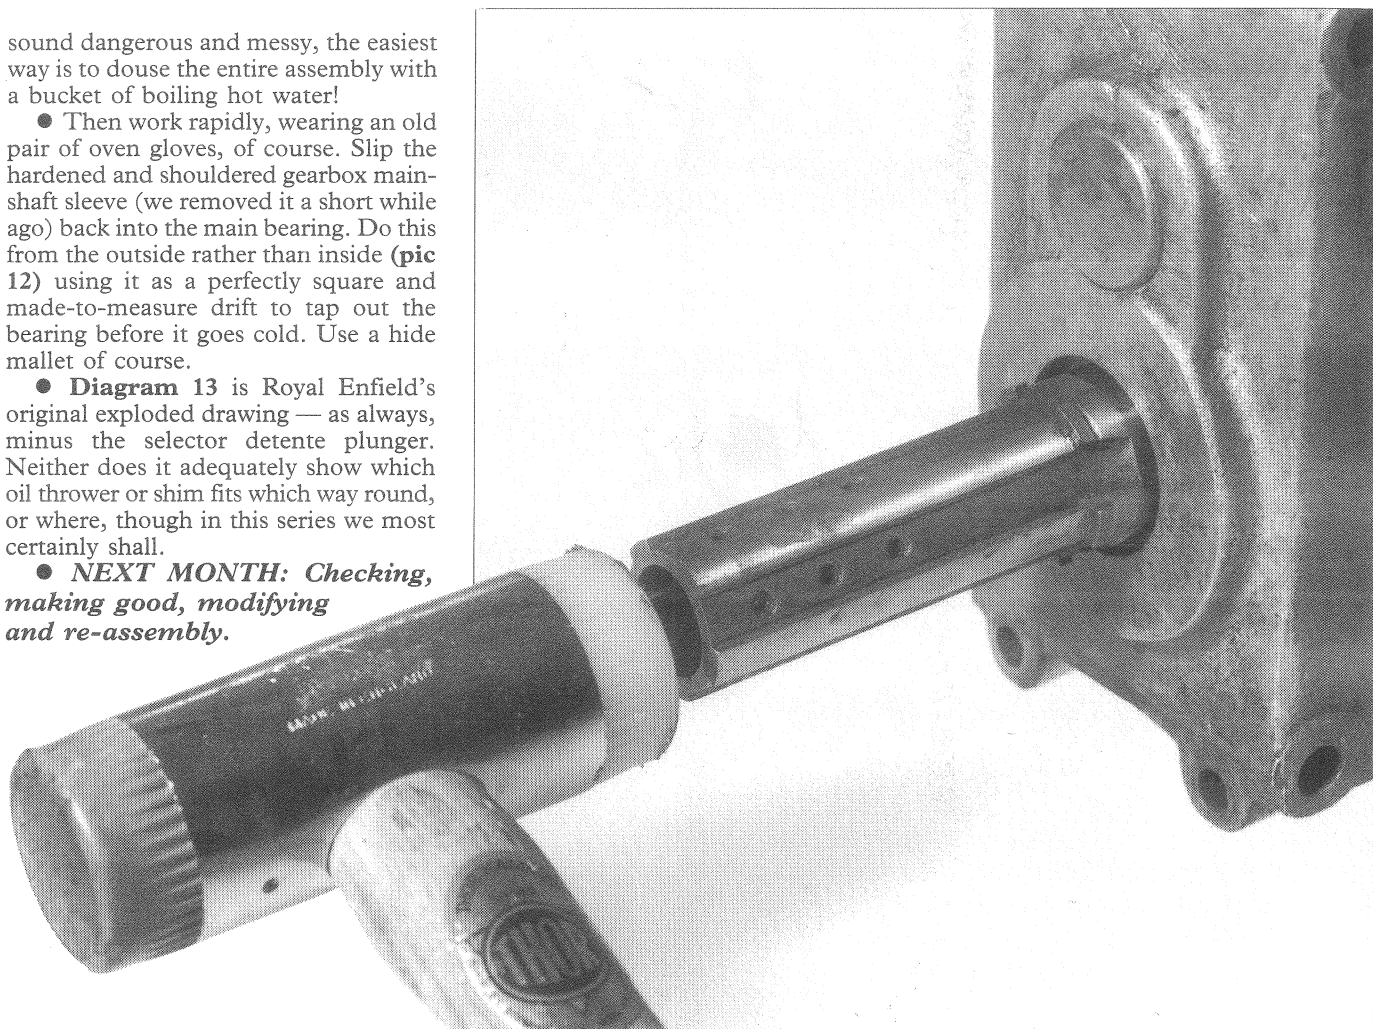
● Then work rapidly, wearing an old pair of oven gloves, of course. Slip the hardened and shouldered gearbox mainshaft sleeve (we removed it a short while ago) back into the main bearing. Do this from the outside rather than inside (**pic 12**) using it as a perfectly square and made-to-measure drift to tap out the bearing before it goes cold. Use a hide mallet of course.

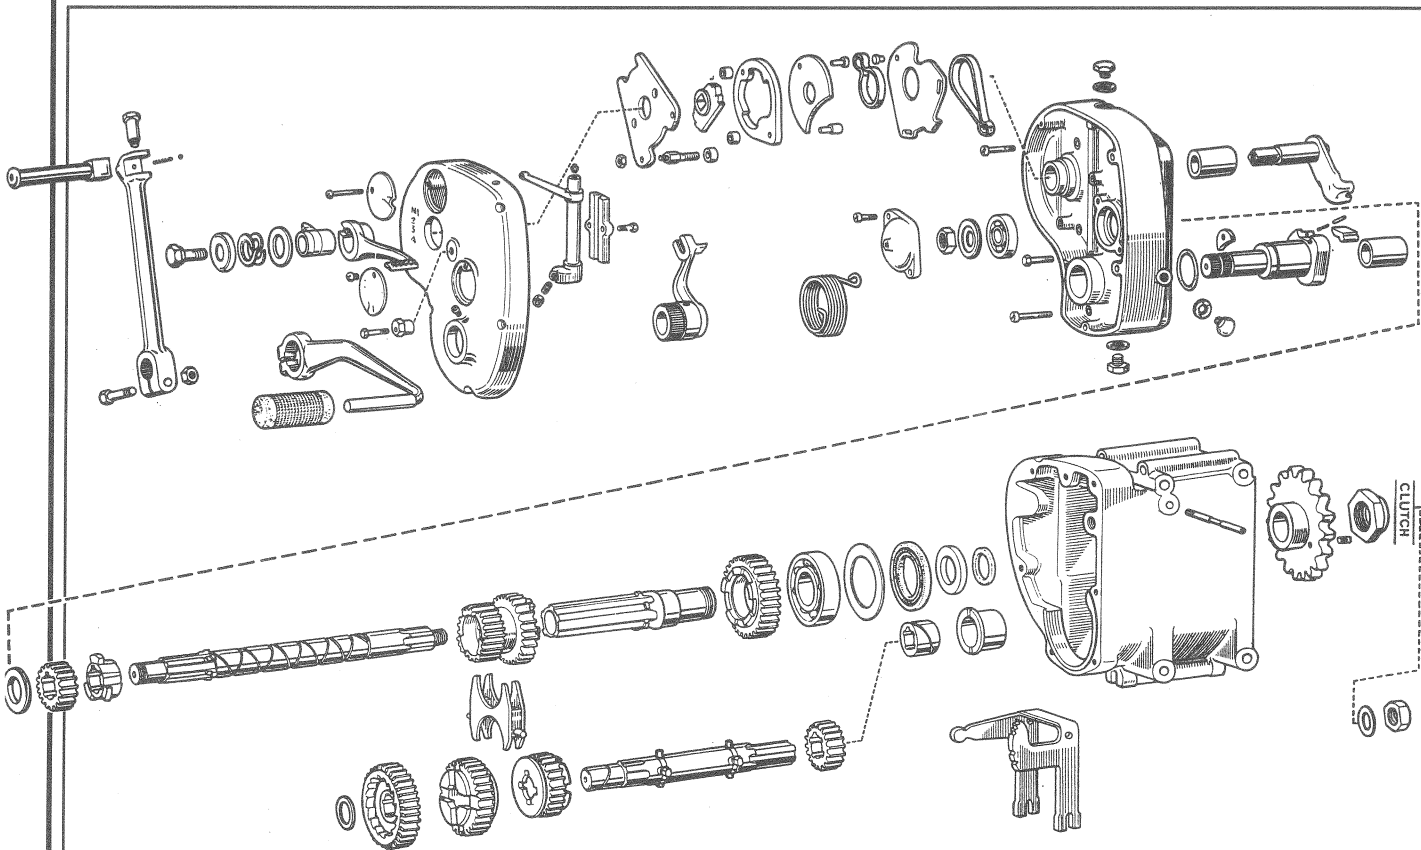
● **Diagram 13** is Royal Enfield's original exploded drawing — as always, minus the selector detente plunger. Neither does it adequately show which oil thrower or shim fits which way round, or where, though in this series we most certainly shall.
