FINAL INSPECTION BEFORE THE REBUILD

With the transmission and gearbox stripped and cleaned, there are some vital checks to be made before putting in back together. Don Morley explains how to do it all properly.

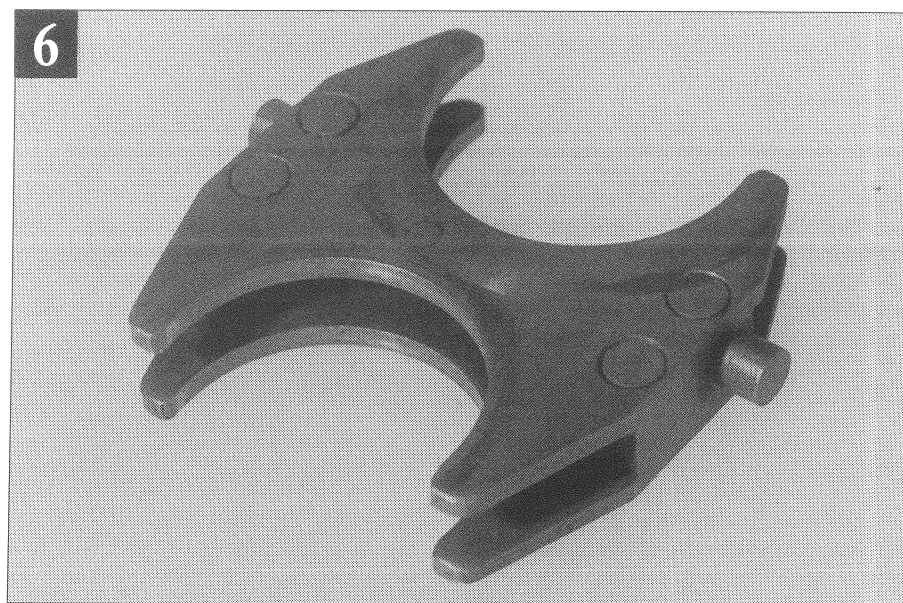
- The gear selector inner sliding plate (**picture six**) is often fitted back to front — and it doesn't seem to make any difference to the gearbox. Luckily, it can't be fitted upside down due to the half moon shaped radiused being slightly different.

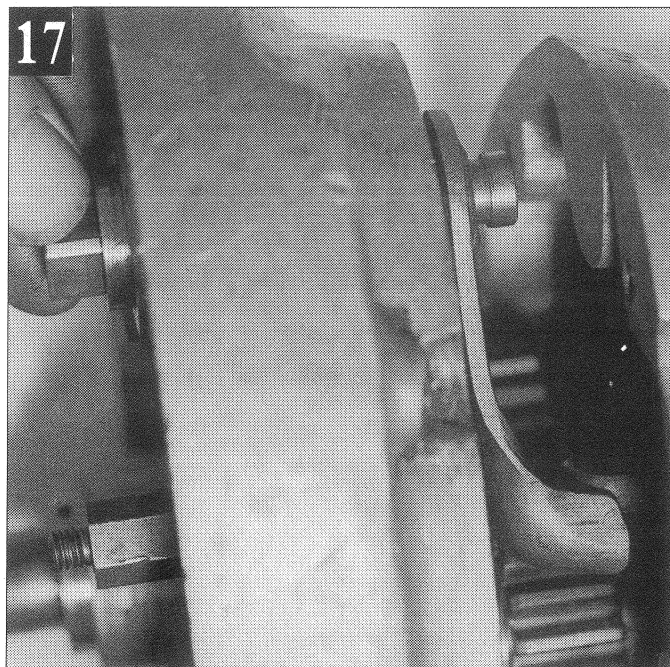
- Importantly, just pause a moment or two for a last look inside before mating up the inner cover with the main castings. At this point, as the cover is pushed home (**picture 17**) the spoon-ended internal gearchange lever inside the inner cover needs to be precisely lined up to engage with the selector fork prong inside the gearbox.

- Without this occurring the gearbox will not change gear due to there being

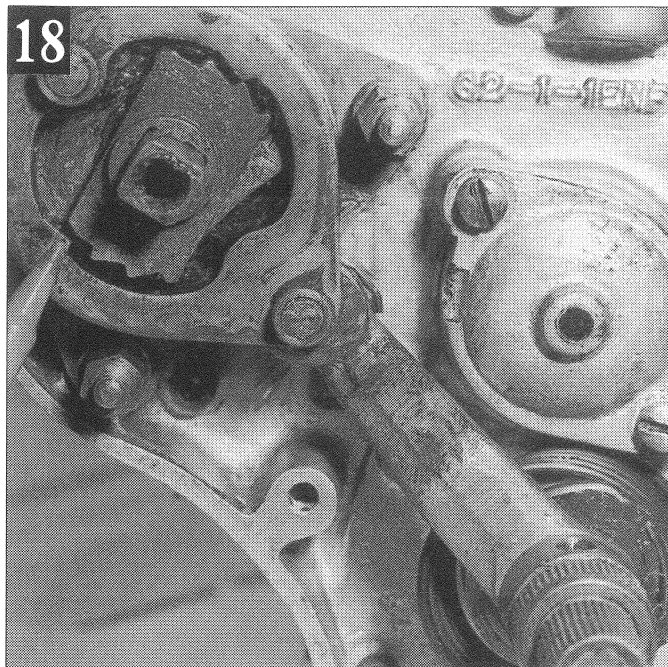
- Once engagement is definitely established we can tighten the fitting screws and begin adding the various other components which live between the inner and outer covers. Again, remember that the gear selector striker plate (**picture 18**) can easily be fitted upside down and/or the wrong way round. If so, it won't work.

- This is the correct position, though it should have an equal gap either side of its teeth and the main plate when the gearbox is in neutral. This can be positionally fine-tuned by slackening off each of the backplate pillar bolts, then rotating the plate fractionally in the required direction.
